Issue 7: Crosswalk at Alameda & Sharon Rd

Overview:

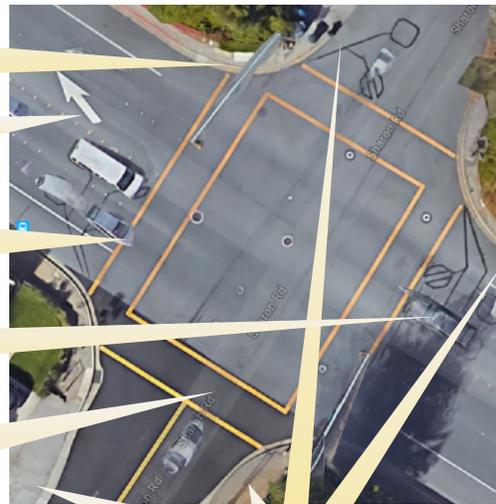
- All 4 Curbs corners are full height — not ADA compliant
- Road narrows to single lane
- No stop limit line at crosswalk and cars often enter it ✓
- No turn lane, approaching cars swerve around stopped cars
- Traffic light does not provide an 'all red' delay for safe pedestrian ✓

Sidewalks virtually non-existent - pathways unsafe, poorly defined

- No sidewalks and limited pathways
- No stop limit lines to move stopped traffic away from crosswalks and create safe zone with visibility
- High accident rate - near misses
- Major road configuration changes
- No left turn lane
- No bike lane guidance
- Speed limit is raised just for this crosswalk and the next 4 blocks

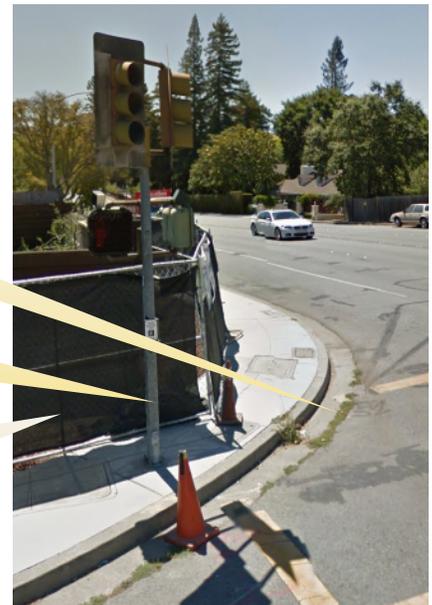
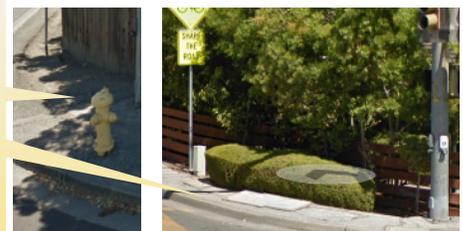
Curbs are not cut for ADA access

Traffic lights are smack in the middle of walkway

This is a new sidewalk section associated with recent construction, but ADA errors were allowed

Fire hydrants, traffic lights, traffic signs, all block the middle of walkway. Raised and uneven in-pavement boxes create a very unsafe and difficult walkway.

Solution is to make each curb ADA compliant, doing one at a time to insure least impact of crosswalk use.

Additional action is needed to address the 4 traffic light poles, fire hydrant and other obstacles in the middle of the sidewalk paths that force pedestrians into street.
